# Storm Tide and Wind Impact of Hurricane Sandy Along the Hudson River

Extended Abstract # 40

### ***Case Study - Storm Tide and Wind Impact of Hurricane Sandy along the Hudson River***

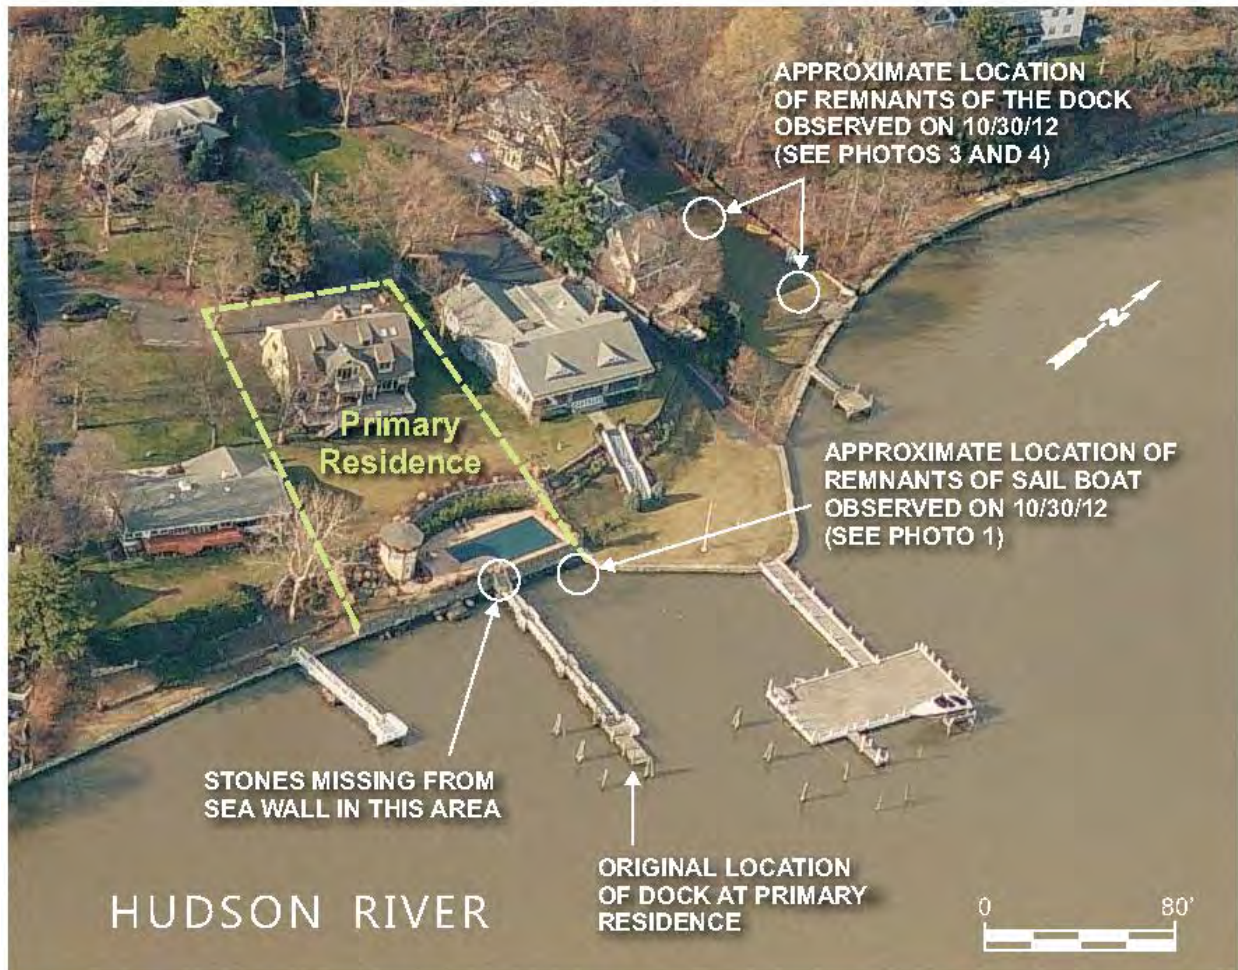
**Figure 1. Detailed location map. Primary residence and adjacent properties.**

- The location where the remnants of the primary residence dock were deposited (Figure 1) is consistent with the estimated height and direction of the storm tide that appears to have deposited the remnants at that location. The dock was clearly picked up and moved into this location by the storm surge, which moved from south to north over the neighbor's adjoining seawall and lawns. By 5 PM on October 29, 2012, the storm surge was already five feet above the predicted tide and almost two feet above a normal high tide and was steadily rising. The highest point of the surge occurred at about 10 PM, after which the flow of the water would begin ebbing and turn southward. The location of the dock remnants are also consistent with the wind direction from the east-southeast observed during the period between 7 PM and 10 PM, which would have pushed the dock to the northwest. Therefore the dock most likely had broken loose and had been deposited on the neighbor's lawn before about 10 PM.

- The final location of sailboat remnants (Figure 1), and the battered condition of those remnants (Photo 1) is indicative of repeated collisions having occurred with the sea wall and remaining dock structures at or near the primary residence.

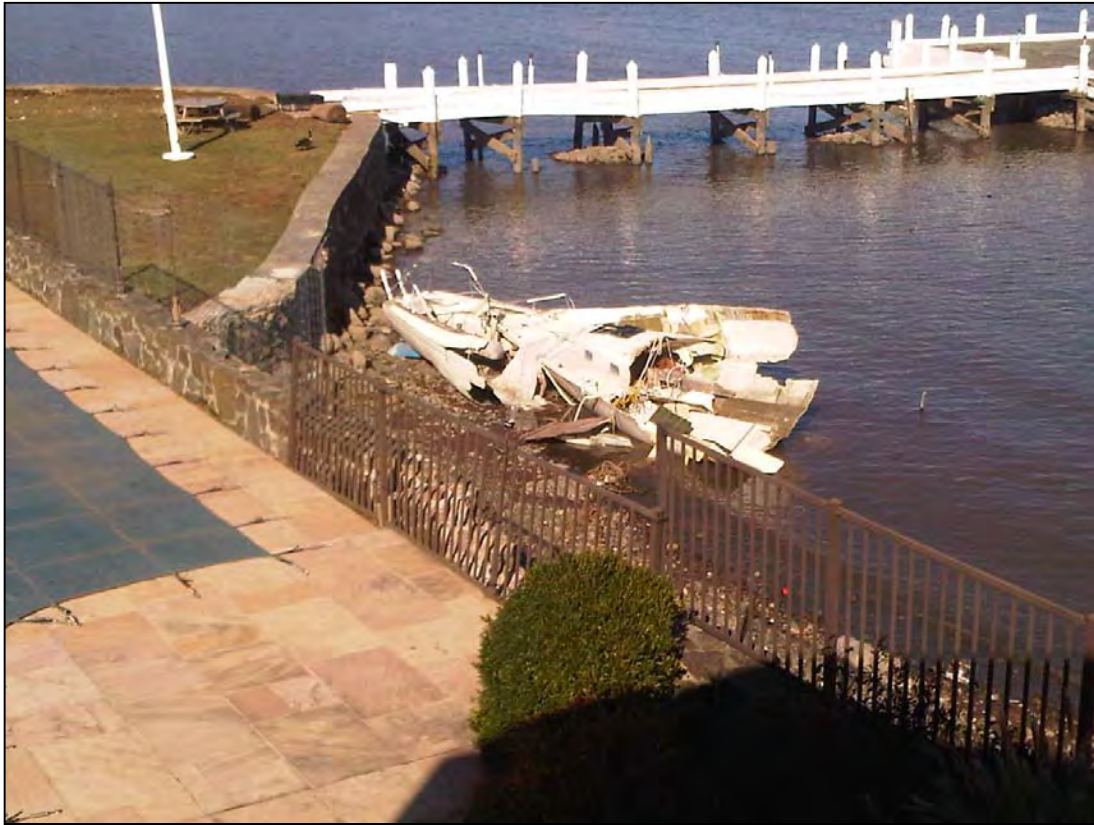
**Photo 1. Primary Residence (Looking Northeast). Remnants of Fiberglass Sailboat that Allegedly Struck Primary Residence Dock.**

During this same nighttime period, the neighbor's sailboat was set free from its moored location due to the effects of Sandy. The boat was broken apart into several pieces and, ultimately, portions of the bow and stern were found partially submerged in the water adjoining the northeast corner of the homeowner's property (Photo 1). The final location of the remainder of the boat (including the central portion of the hull, the keel and the mast) is not known.

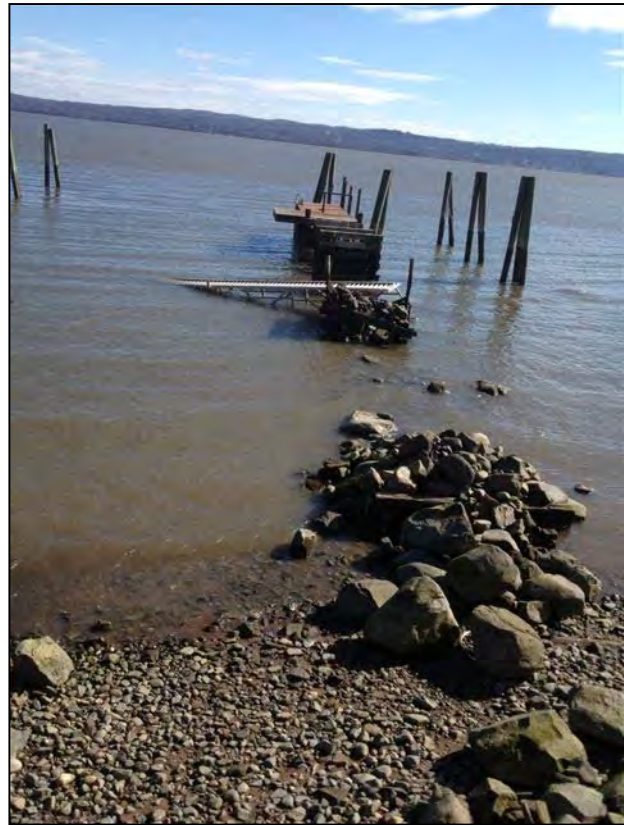
**Photo 2. From Original Dock Location: Remnants of Primary Residence Dock Looking East.**

On March 4, 2013, well after the effects of Sandy had been experienced, the author traveled to the primary residence and met the homeowner to conduct an inspection. The homeowner provided a tour to the area of his property adjoining the Hudson River (retaining wall, in-ground pool, gazebo, sea wall, fence, and the portions of dock that were not destroyed). During the inspection, it was observed that very little of the walking surface of the dock remained in place (Photo 2). Properties to the north of the residence (second property to the north) had a lawn and sea wall that were several feet lower than the sea wall at the primary residence (Figure 1). Photos (3 and 4) show details of the second property to the north of the primary residence, where substantial portions of dock walking surface remnants were found after the storm. The distance from the original dock location at the primary residence and the two main locations where the dock remnants were observed ranged from 300 to 450 feet to the northwest.

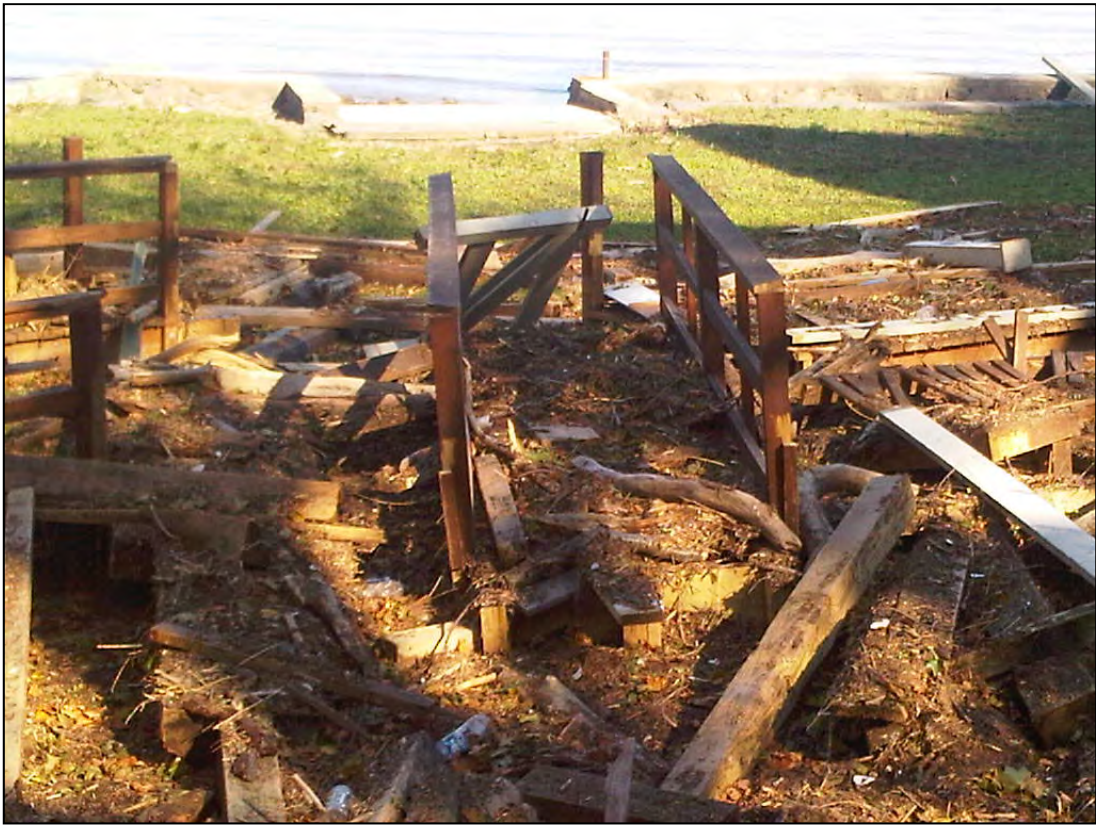
**Photo 3. From Second Property North of Primary Residence Looking East:  
Substantial Portions of Dock Walking Surface Found.**

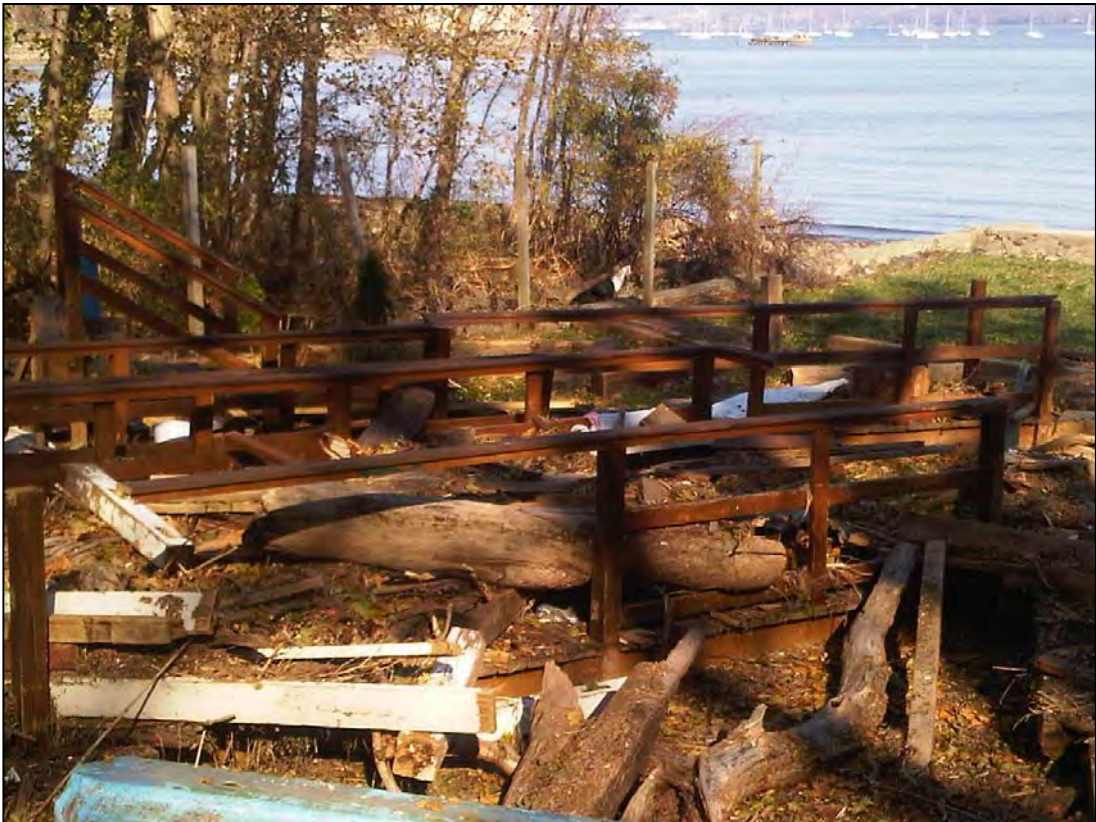
**Photo 4. From Second Property North of Primary Residence Looking Northeast:  
Substantial Portions of Dock Walking Surface Found.**
